## POST OCCUPATIONAL ANALYSIS OF A MODEL VILLAGE IN MUZAFFARGARH: REVIEWING POST DISASTER REHABILITATION EFFORTS BY THE GOVERNMENT IN PUNJAB

<sup>\*1,2,3,4,5</sup>University of Engineering and Technology, Lahore, Pakistan

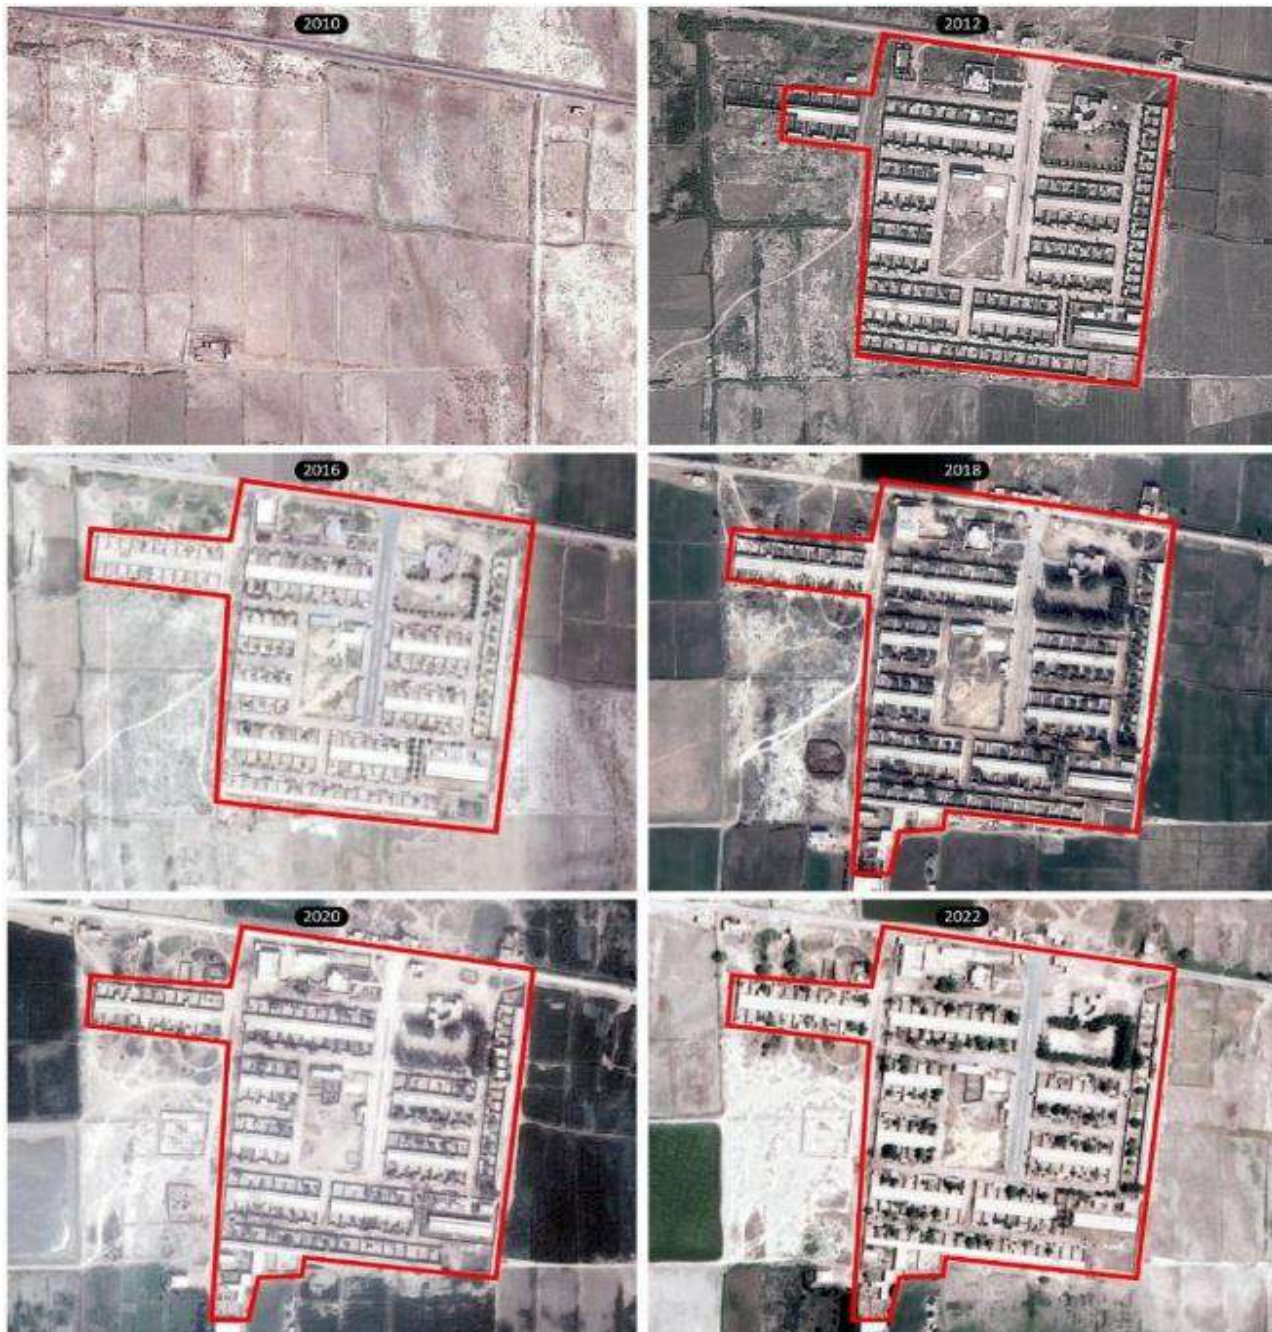
Fig 3: Site Transformation with time (year 2012-2022) (Source: Google Earth)

The Following figure encapsulates a comprehensive examination of the evolution of the site from its inception in 2012 to its current state. The images provided offer a vivid portrayal of the site's transformation, highlighting significant features and

developments over time. Beginning with the observation that the site is newly constructed and not situated on the former village location, the narrative progresses to note the minimal changes after its completion, encompassing aspects such as infrastructure, boundaries, and greenery. Moreover, the presence of numerous fish farms surrounding the

village underscores a burgeoning interest in aquaculture within the community. Notably, the absence of flooding since the site's establishment indicates its resilience and safety, a commendable achievement for land development projects but this point needs to be verified through detailed surveys.

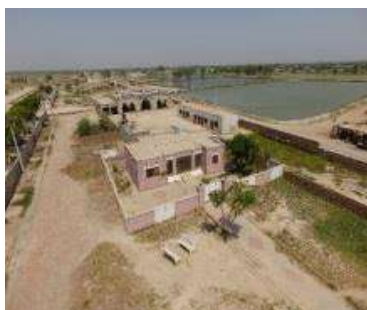
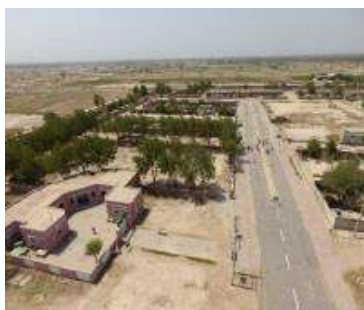
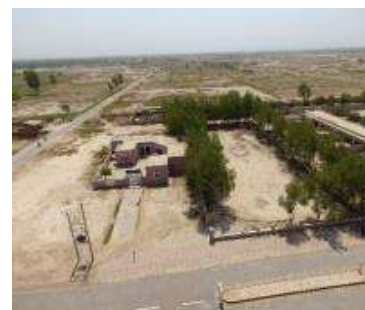
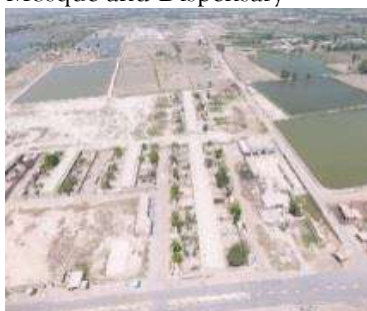
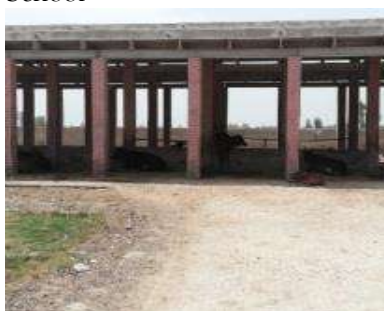
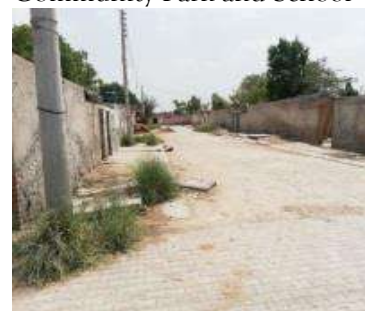
Fig 6: Images of the Model Village Rakh Jalwala (Source: Field Survey)

Mosque and Dispensary

School

Community Park and School

Row of Houses

Cattle Shed

Streets

The community was never consulted before construction of new houses, most of the people highlighted that there were unaware of the design, size, and location of the new houses. Even though relevant data suggests that public consultation before the construction of houses is the key to successful rehabilitation projects but in this case the occupants are majorly satisfied and have very few design grievances [9]. Under the basic design streets were brick paved. The paved streets are in good condition. The show some signs of being worn out but are still fulfilling the purpose for locals and are of reasonably good quality construction which give pleasure to observe as they are mostly clean. The livestock dispensary is in shambles. It is not operational. The building and the walls are damaged. There are no medicines nor a veterinarian. Lack of funds is the reason for its present condition. There is a public park in the middle of the settlement. According to survey initially the park was made with proper boundary and plantation of trees and grass etc. However, due to non-availability of funds, the condition of park has deteriorated. It is not used by locals anymore as

garbage has been disposed there. The boundary grills are broken / missing, there is no greenery. A building for medical dispensary exists and is in good condition, but the dispensary is not functional since beginning. The local government should allocate funds to make it functional by providing medicines and services of a medical practitioner.
